AGRICULTURAL TERRACED LANDSCAPE DEGRADATION DRIVEN BY HYDROLOGICAL AND GEOMORPHOLOGICAL PROCESSES

Giacomo Pepe*

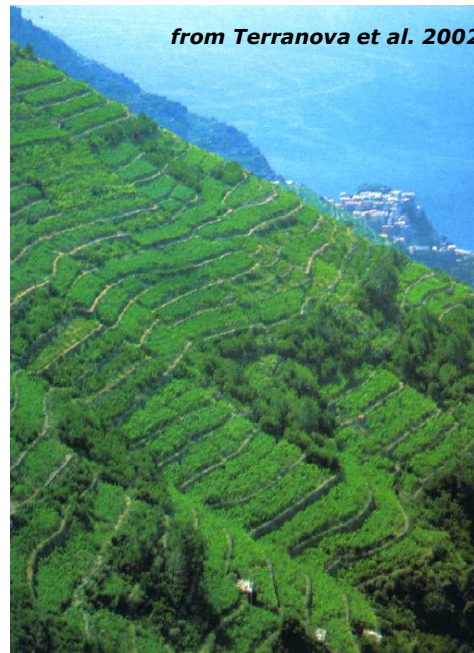
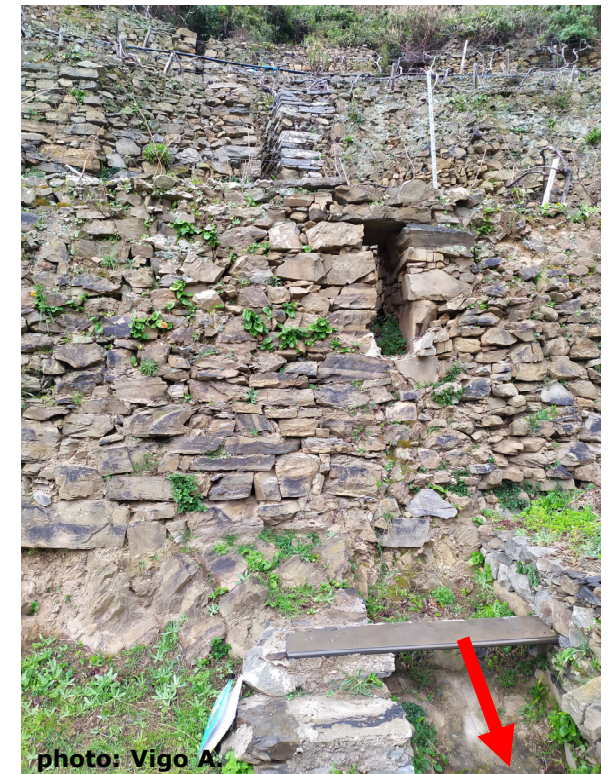
Terraced slopes with terraces sustained by dry-stone walls in Cinque Terre (Italy)

Artificial drainage works

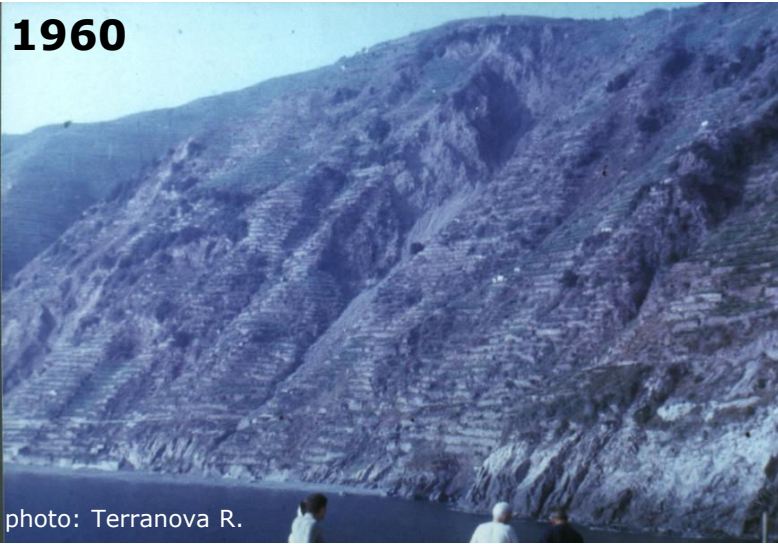
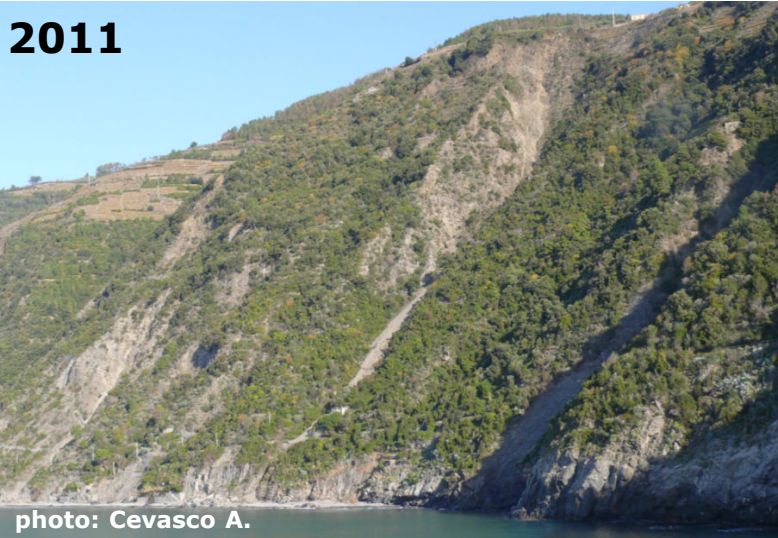
Terraced landscape abandonment: comparison between terraced slopes in 1960 (top) and 2011 (bottom) in Cinque Terre (Italy)

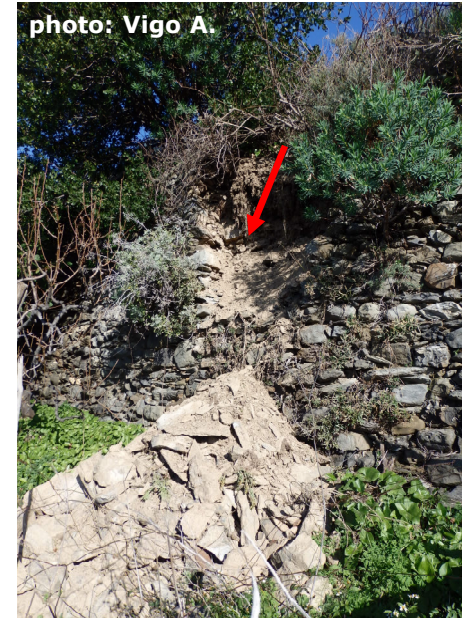
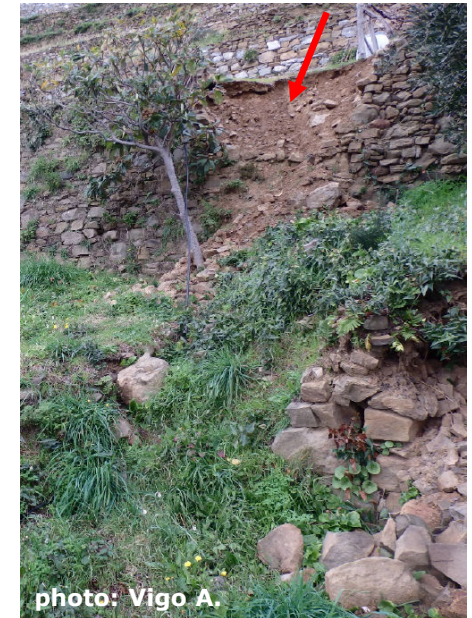
- Progressive collapse of dry-stone walls and terrace risers
- Obstruction of artificial drainage channels

Dry-stone walls deformations & collapses

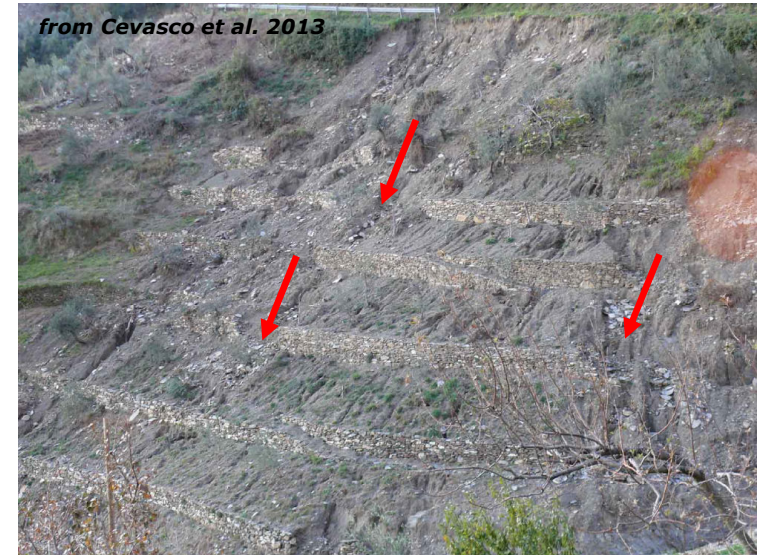
Terraced slope affected by rill erosion

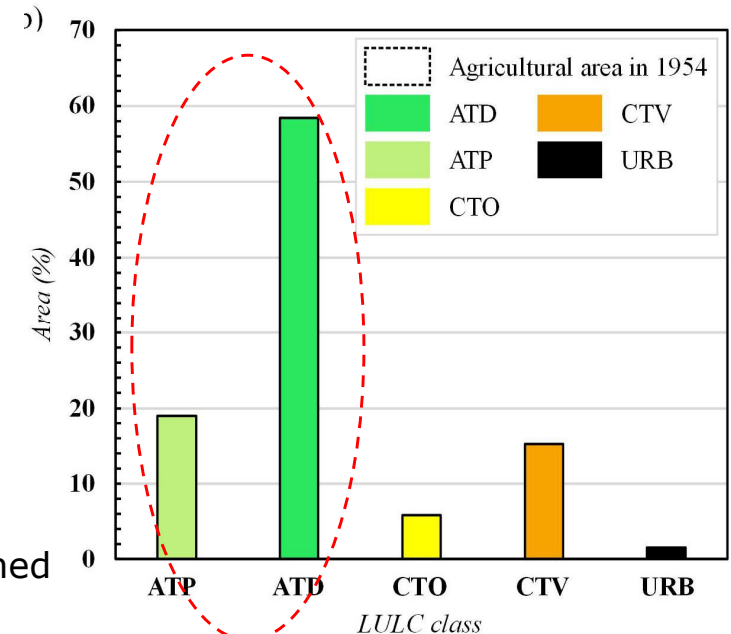
LULC setting of the 1954 agricultural area

Over ≈60 years, 77.4% of agricultural terraced slopes has been abandoned while 21.1% remained cultivated.

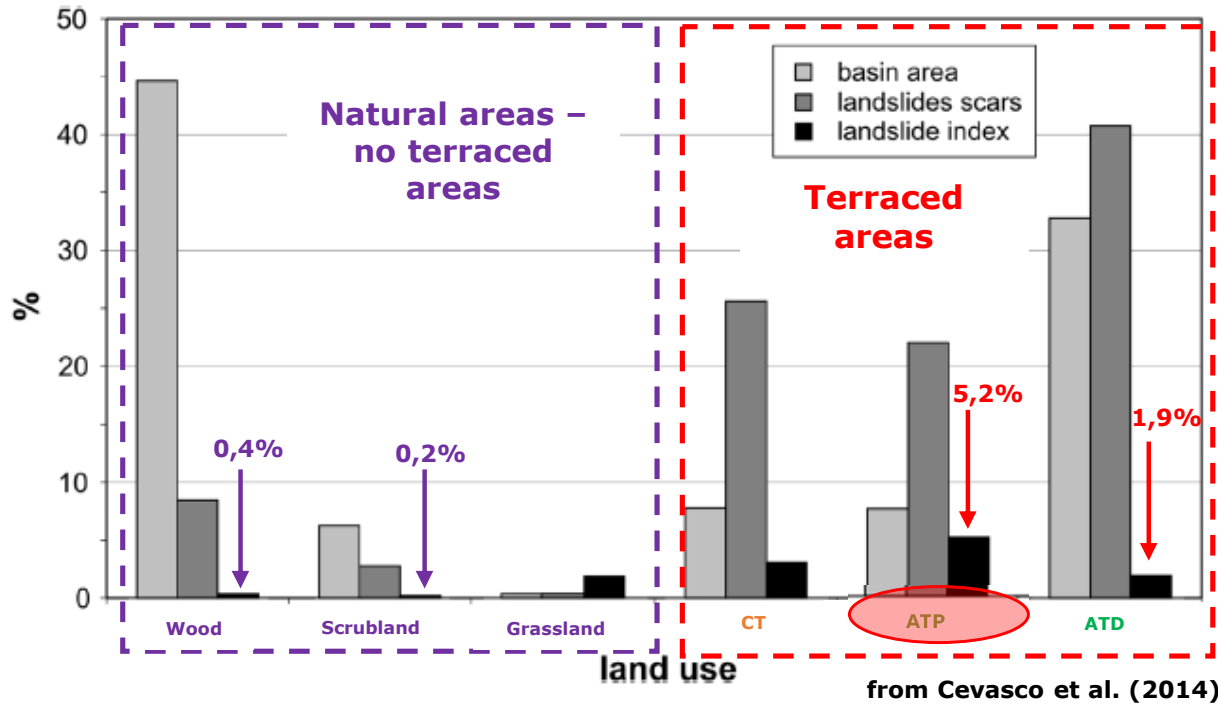
The role of land-use on rainfall-induced effects

Terraced areas vs no terraced areas

ATD - abandoned terraced slope with dense cover
 ATP - abandoned terraced slope with poor cover
 CT - cultivated terraced slope

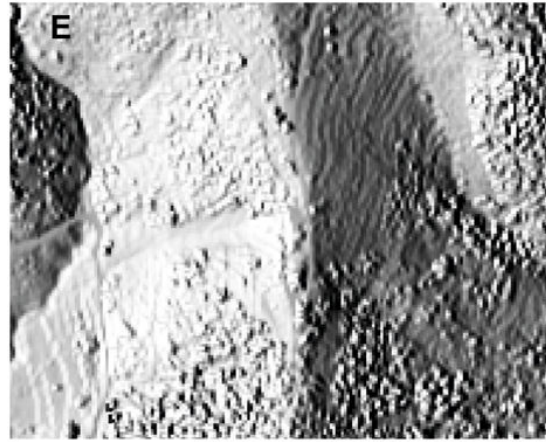
post landslide event DEM

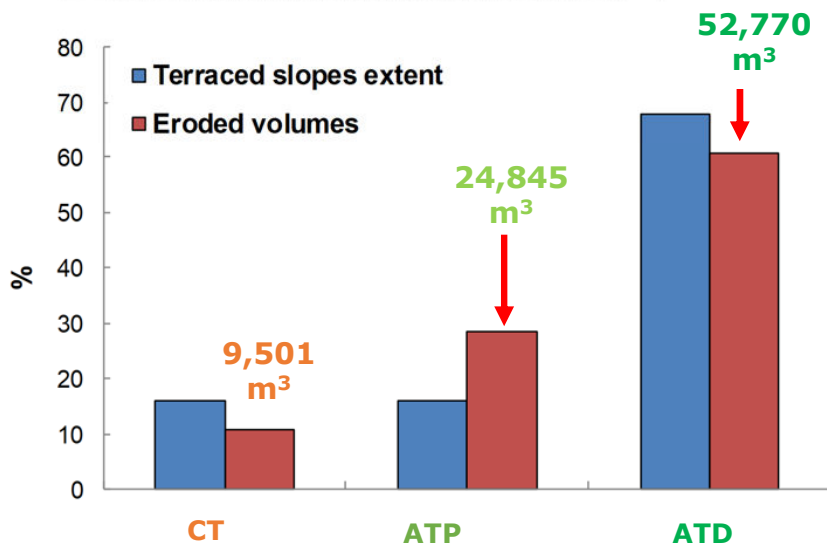
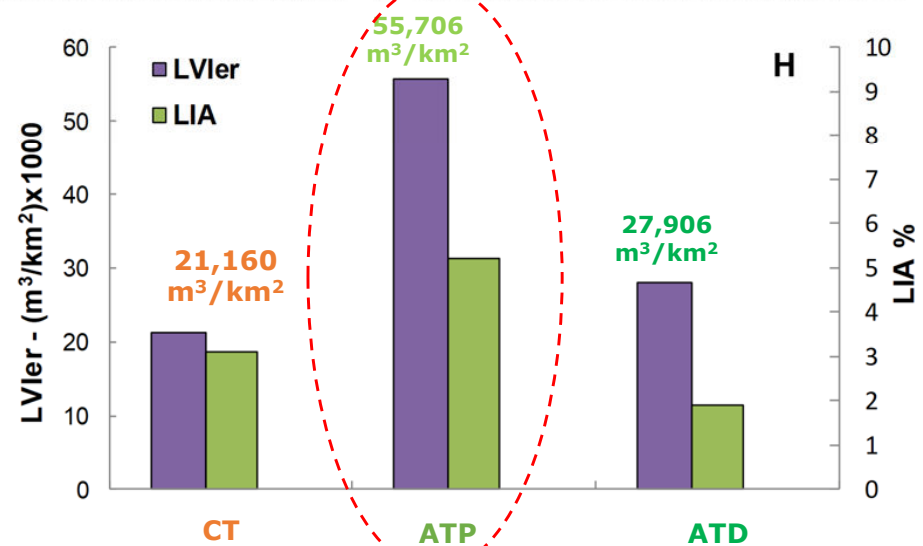
$$LVI_{er,i} = \frac{V_{t_{er,i}}}{A_i}$$

$$LIA = \frac{A_{landslide_i}}{A_i}$$

LVI_{er}: Landslide Volumetric Index

LIA: Landslide Index

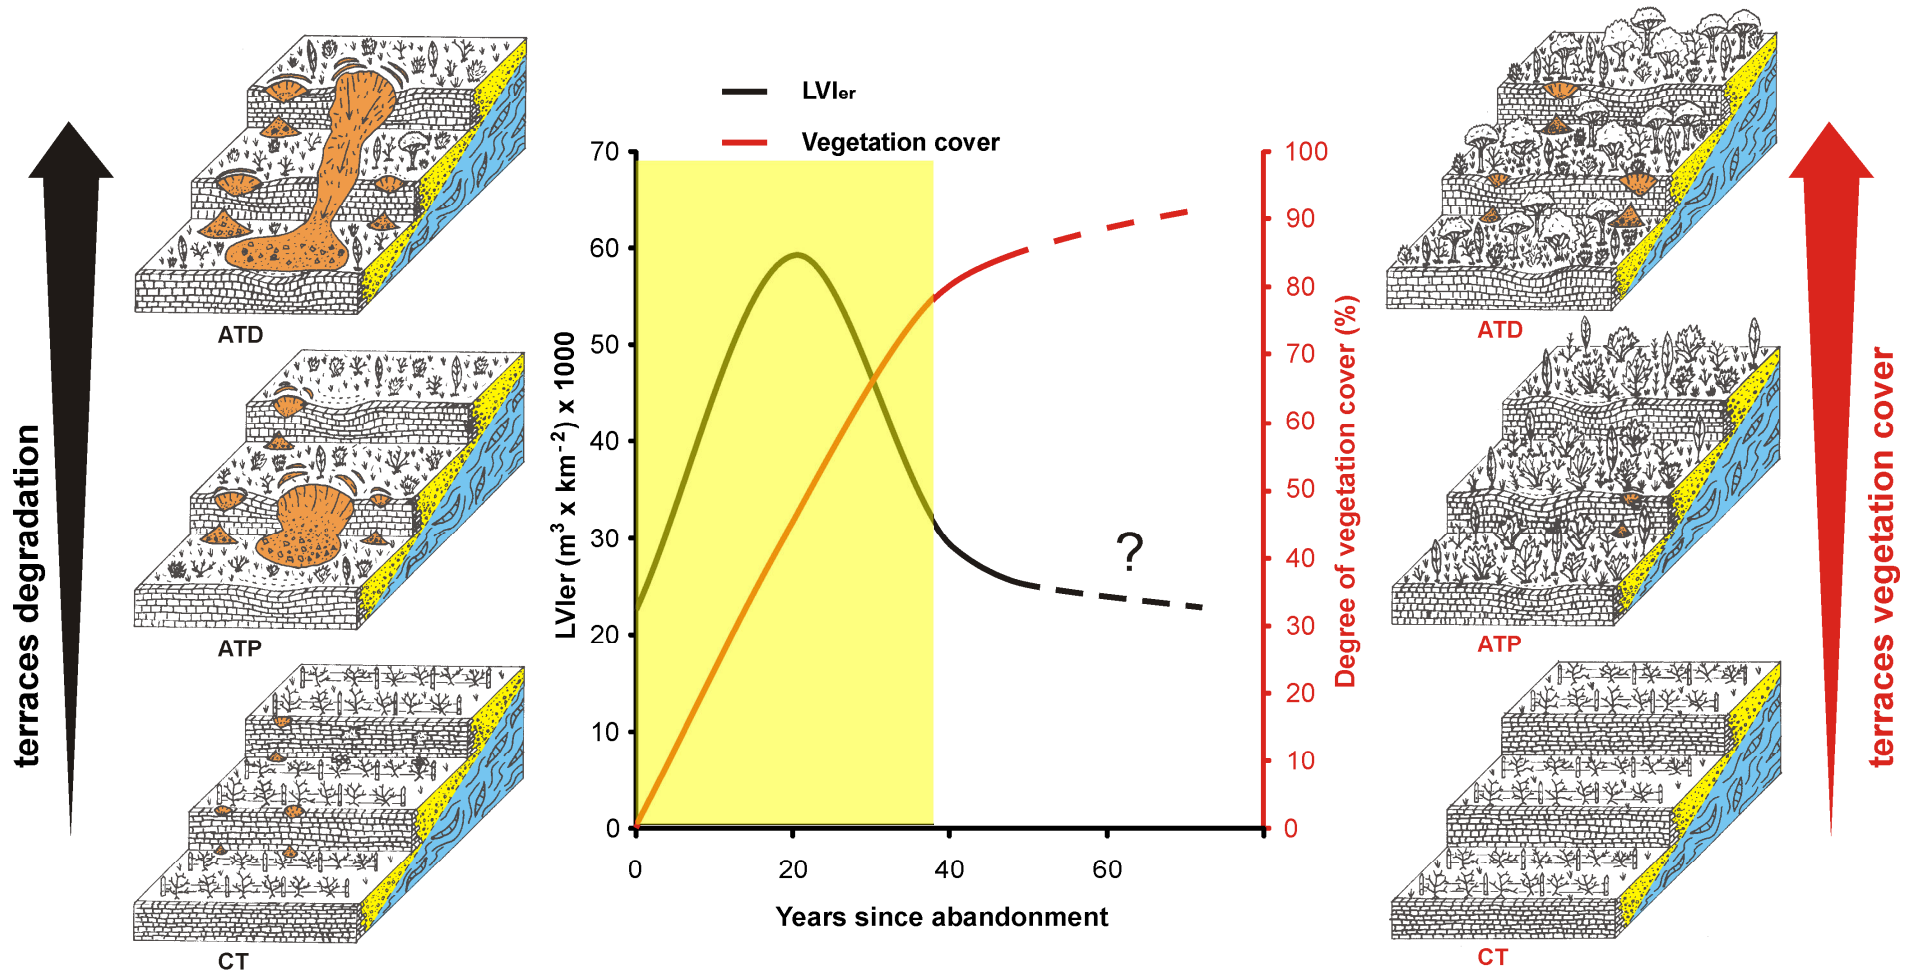
Slope degradation vs time since abandonment vs vegetation growth
