**Giacomo Pepe<sup>1\*</sup>, Andrea Vigo<sup>1</sup>, Andrea Mandarino<sup>1</sup>, Emanuele Raso<sup>2</sup>, Francesco Marchese<sup>2</sup>, Diego Di Martire<sup>3</sup>, Giacomo Russo<sup>3</sup>, Luigi Guerriero<sup>3</sup>, Patrizio Scarpellini<sup>2</sup>, Marco Firpo<sup>1</sup>, Domenico Calcaterra<sup>3</sup>, Andrea Cevasco<sup>1</sup>**

The research activities described are in the framework of the a LIFE EU-project **"STONEWALLS4LIFE" (S4L)**, which is aimed at investigating the role of dry-stone walls in increasing the resilience of rural areas and in counteracting the impacts of climate change (Fig. 7).

The S4L terraced pilot site (12.5 ha) surrounds the Manarola hamlet (E Liguria, NW Italy), at the outlet of the small V-shaped Groppo valley (Cinque Terre National Park) (Figs. 8-9).

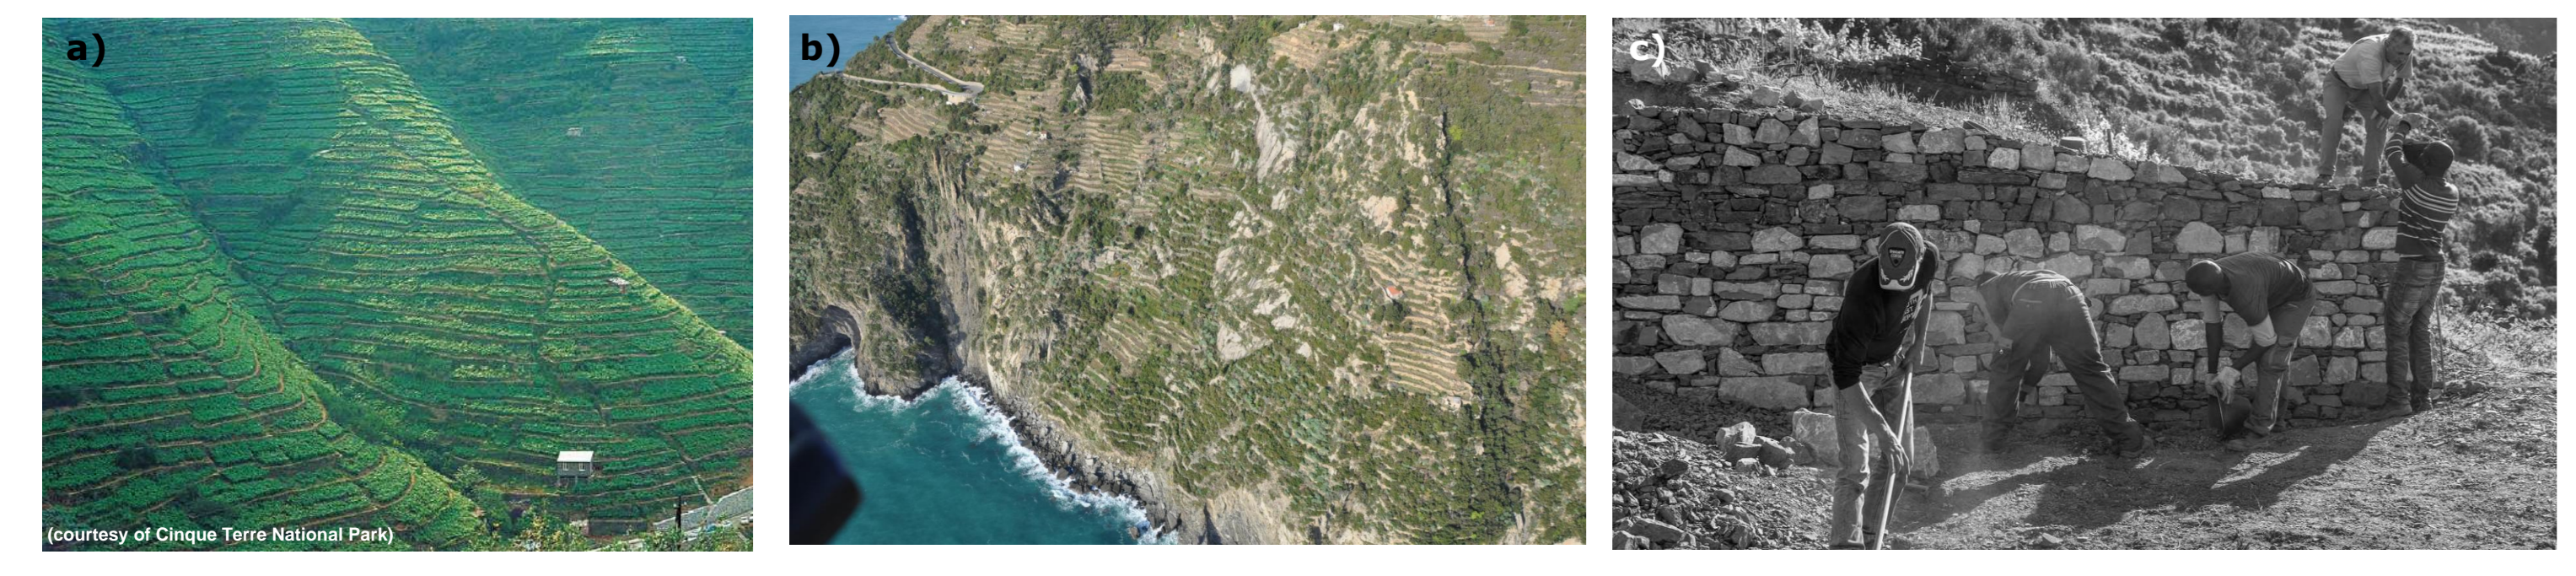
Fig. 1 (a-b) Terraced slopes along the coast of Cinque Terre (Italy); (c) dry-stone walls construction activities.

**Dry-stone wall terraces** are among the most ancient and widespread agricultural practices on hilly-mountainous landscapes (Fig. 1a-b). Their historical, architectural, and environmental value has been recognized worldwide. Recently, "the art of dry-stone walls" was inscribed on the UNESCO Representative List of the Intangible Cultural Heritage of Humanity (Fig. 1c).

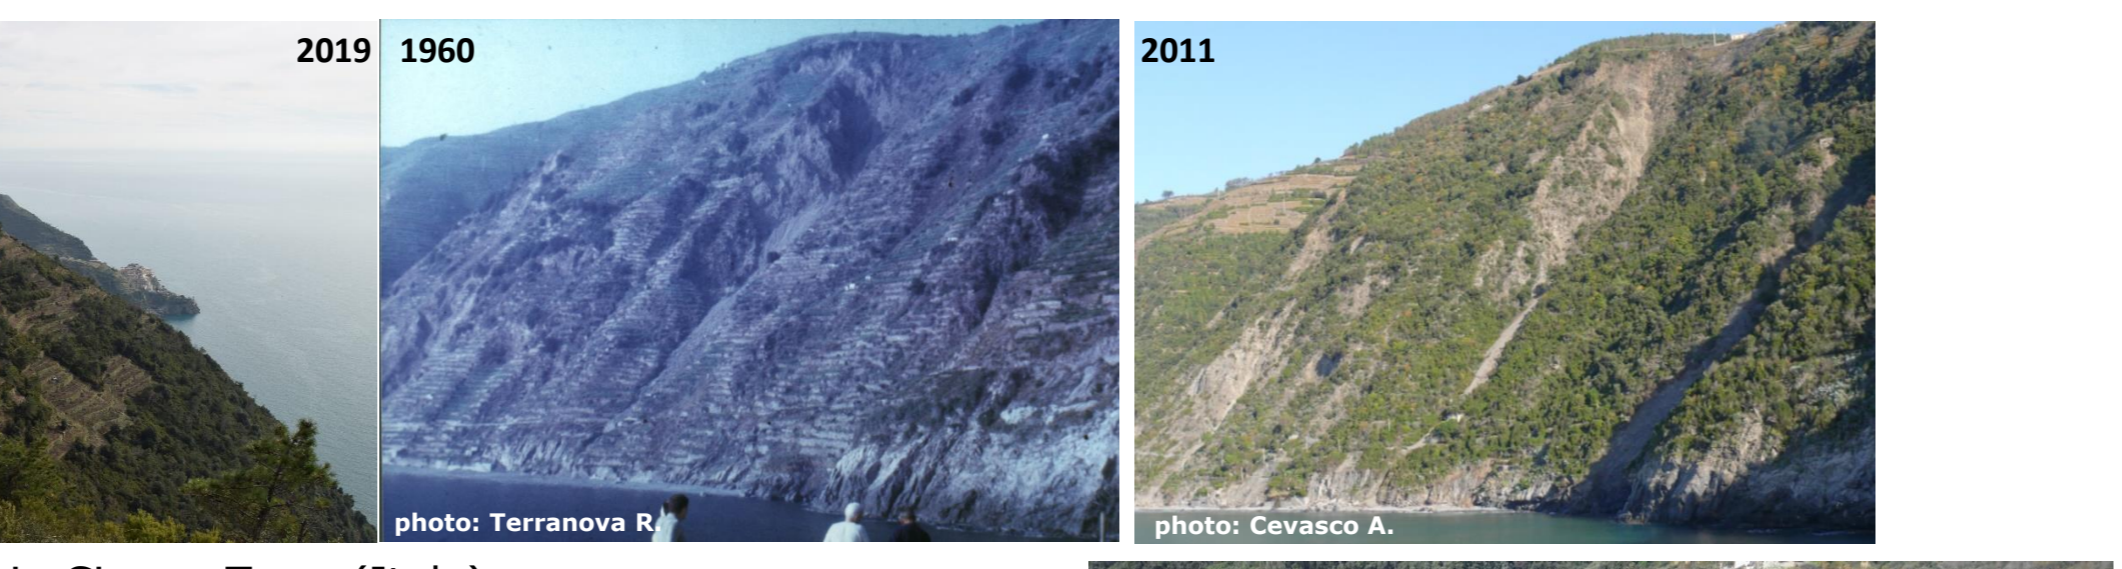
Fig. 3 Examples of terrace evolution following abandonment in Cinque Terre (Italy).

Due to **abandonment & lack of maintenance**, terraces may progressively lose their hydro-geomorphological functions (Fig. 3).

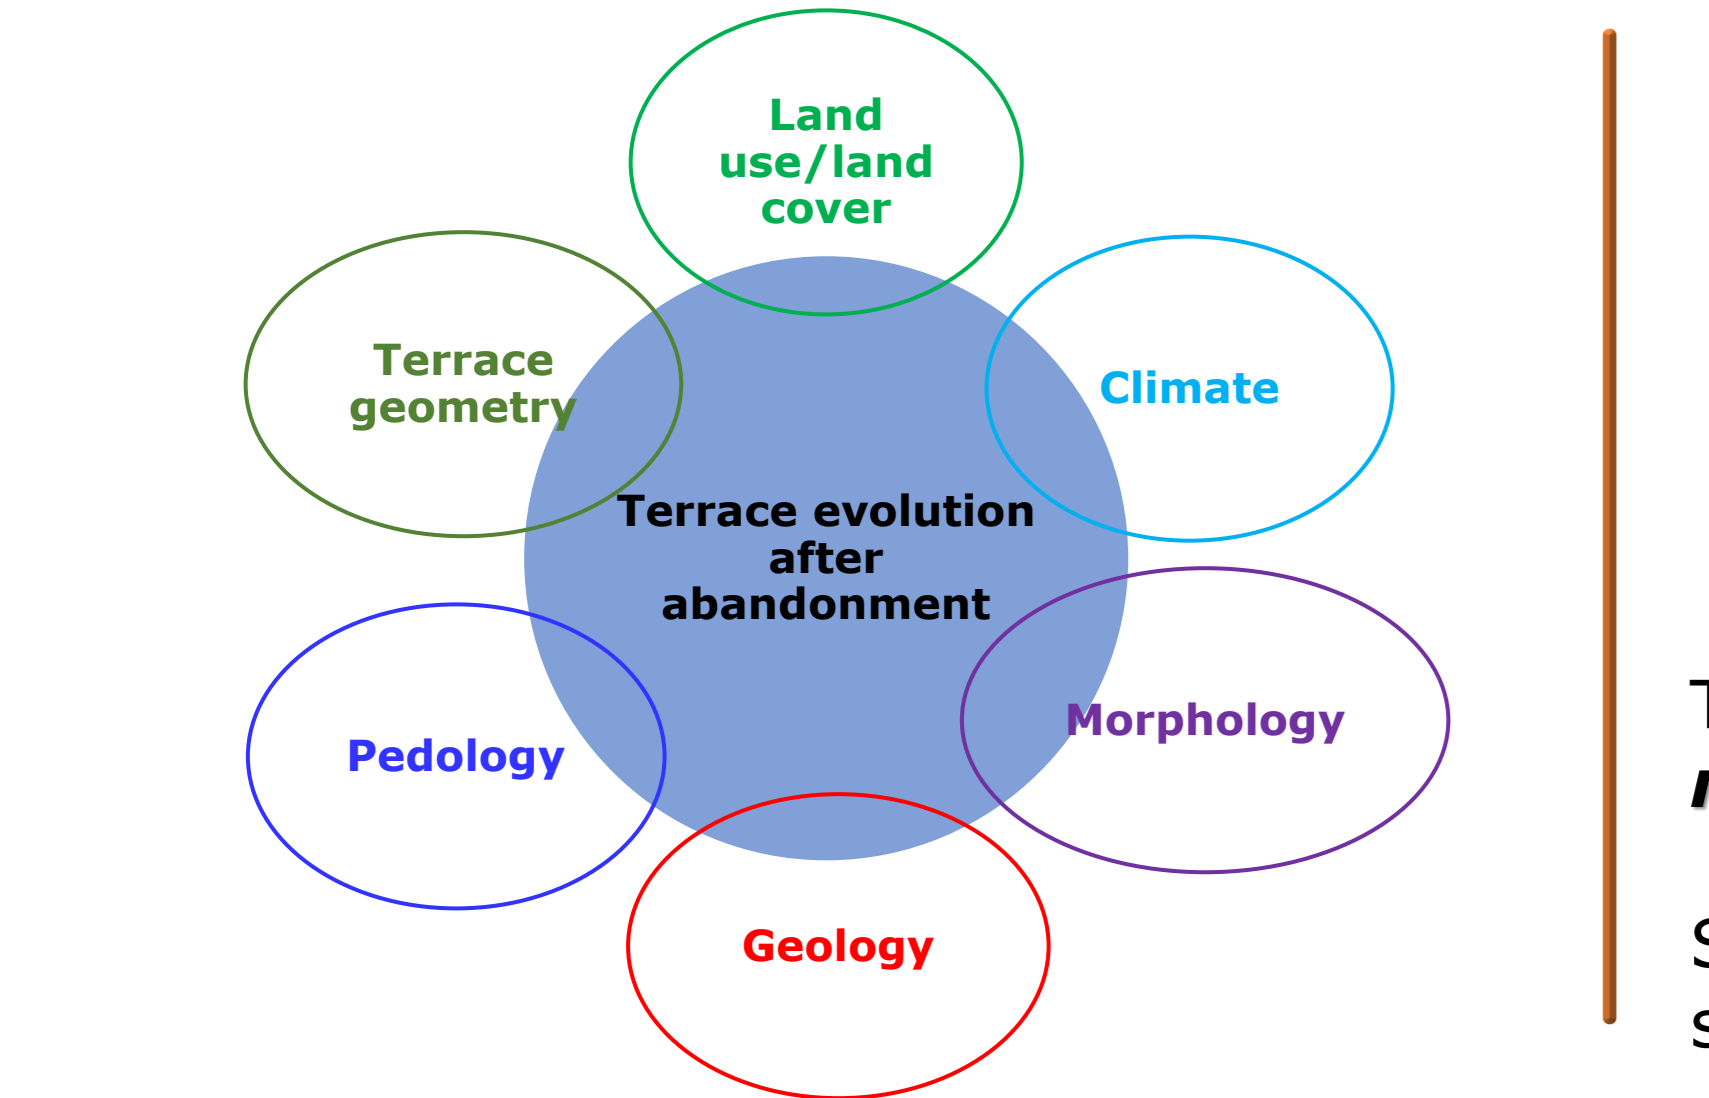
Fig. 6 Factors that can influence the hydro-geomorphological response of terraces after abandonment (adapted from Moreno-de-las-Heras et al. 2019)

Several factors affect the hydro-geomorphological response of terraced systems after abandonment (Fig. 6).

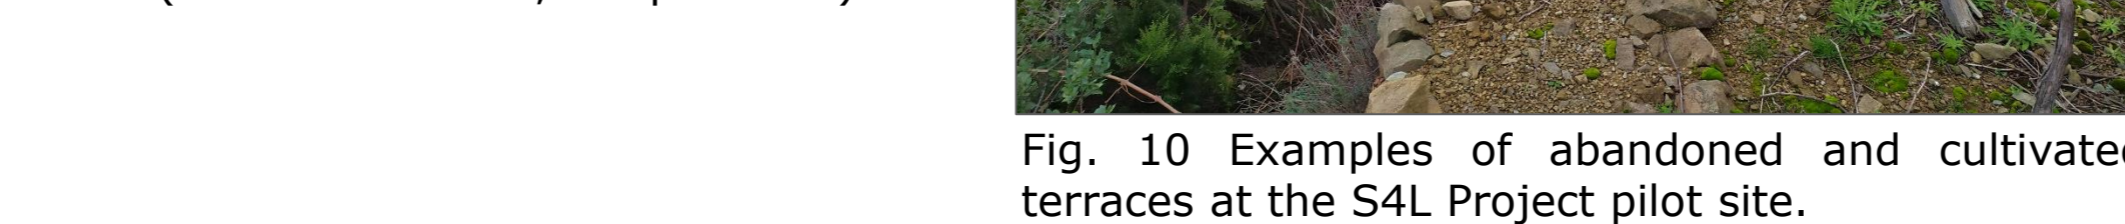
Fig. 10 Examples of abandoned and cultivated terraces at the S4L Project pilot site.

- Explore the **effects of land use & of management practices** of dry-stone wall terraces.
- Investigate the **hydro-geotechnical behaviour** of dry-stone wall terraces in different **land use conditions & state of management** (Fig. 10).

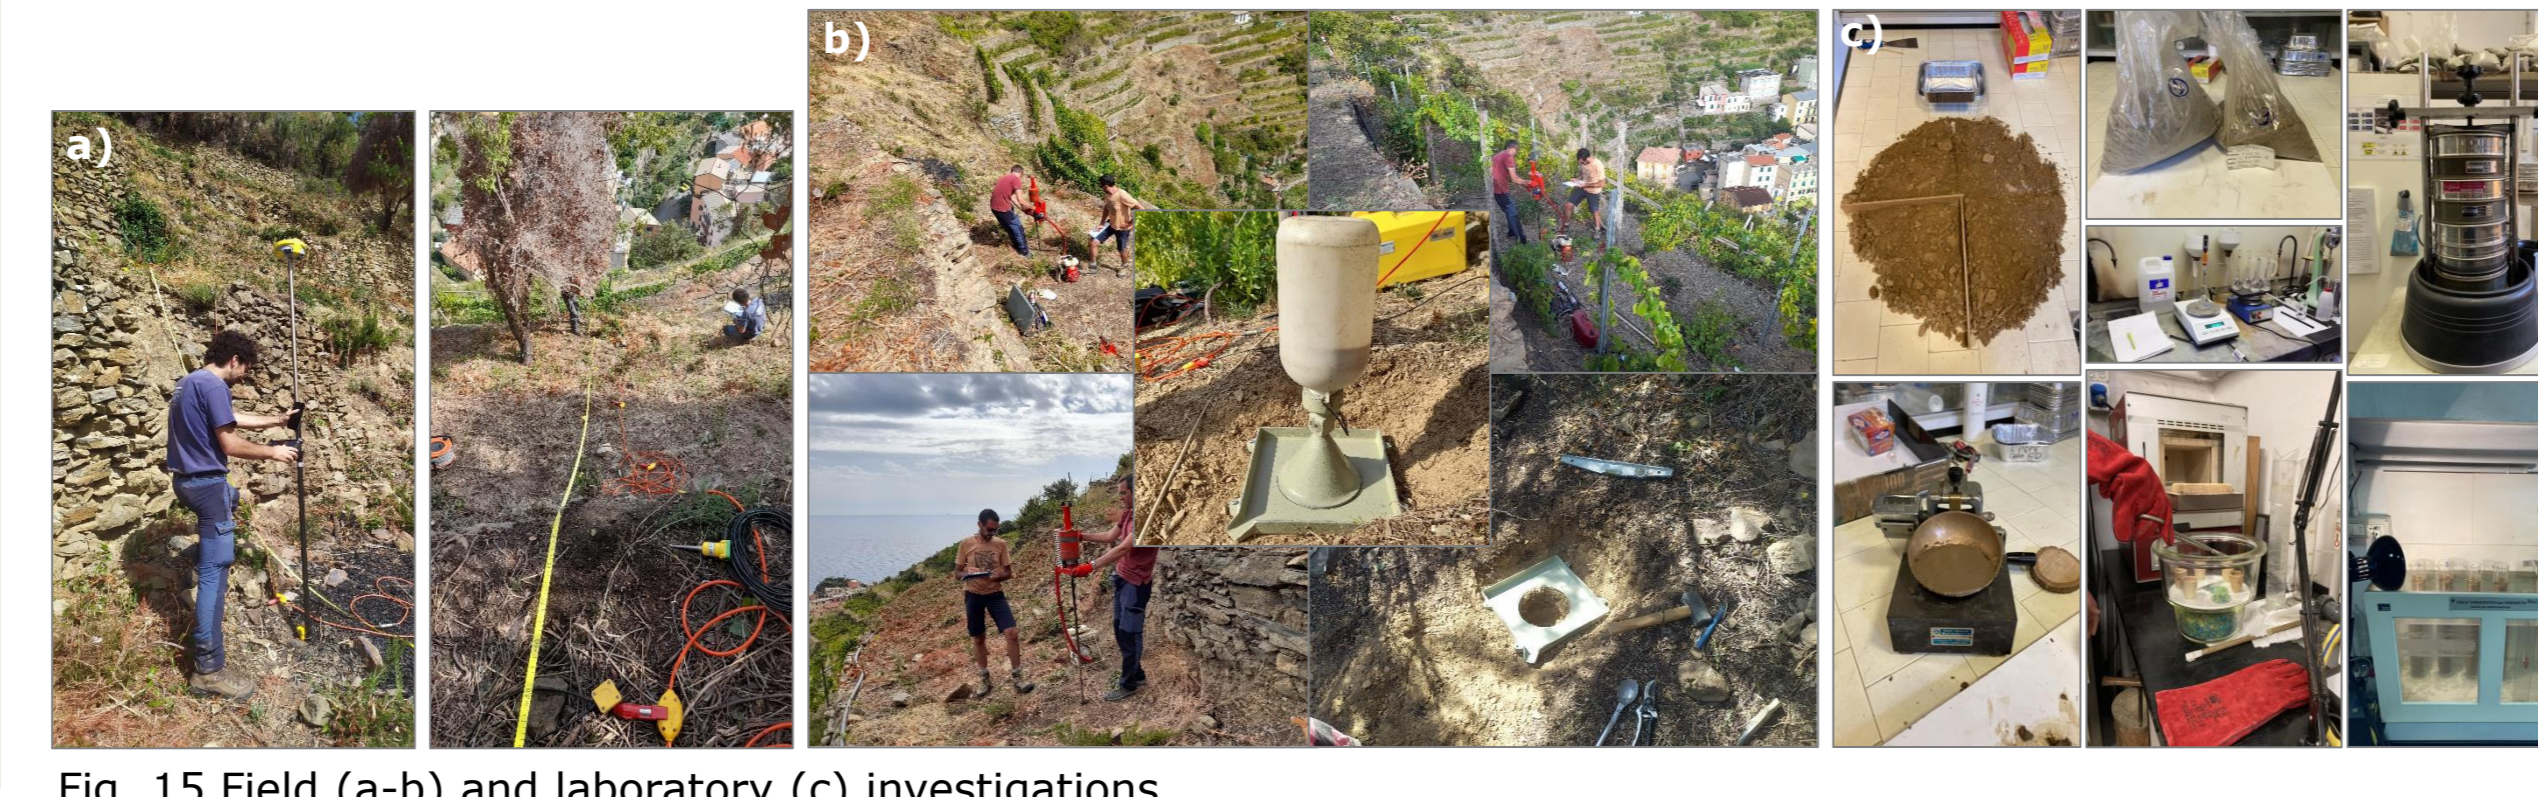
Fig. 15 Field (a-b) and laboratory (c) investigations.

- (i) geophysical surveys
- (ii) GNSS surveys
- (iii) geological & geomorphological field surveys
- (iv) in situ & laboratory geotechnical tests
- (v) shallow test pits

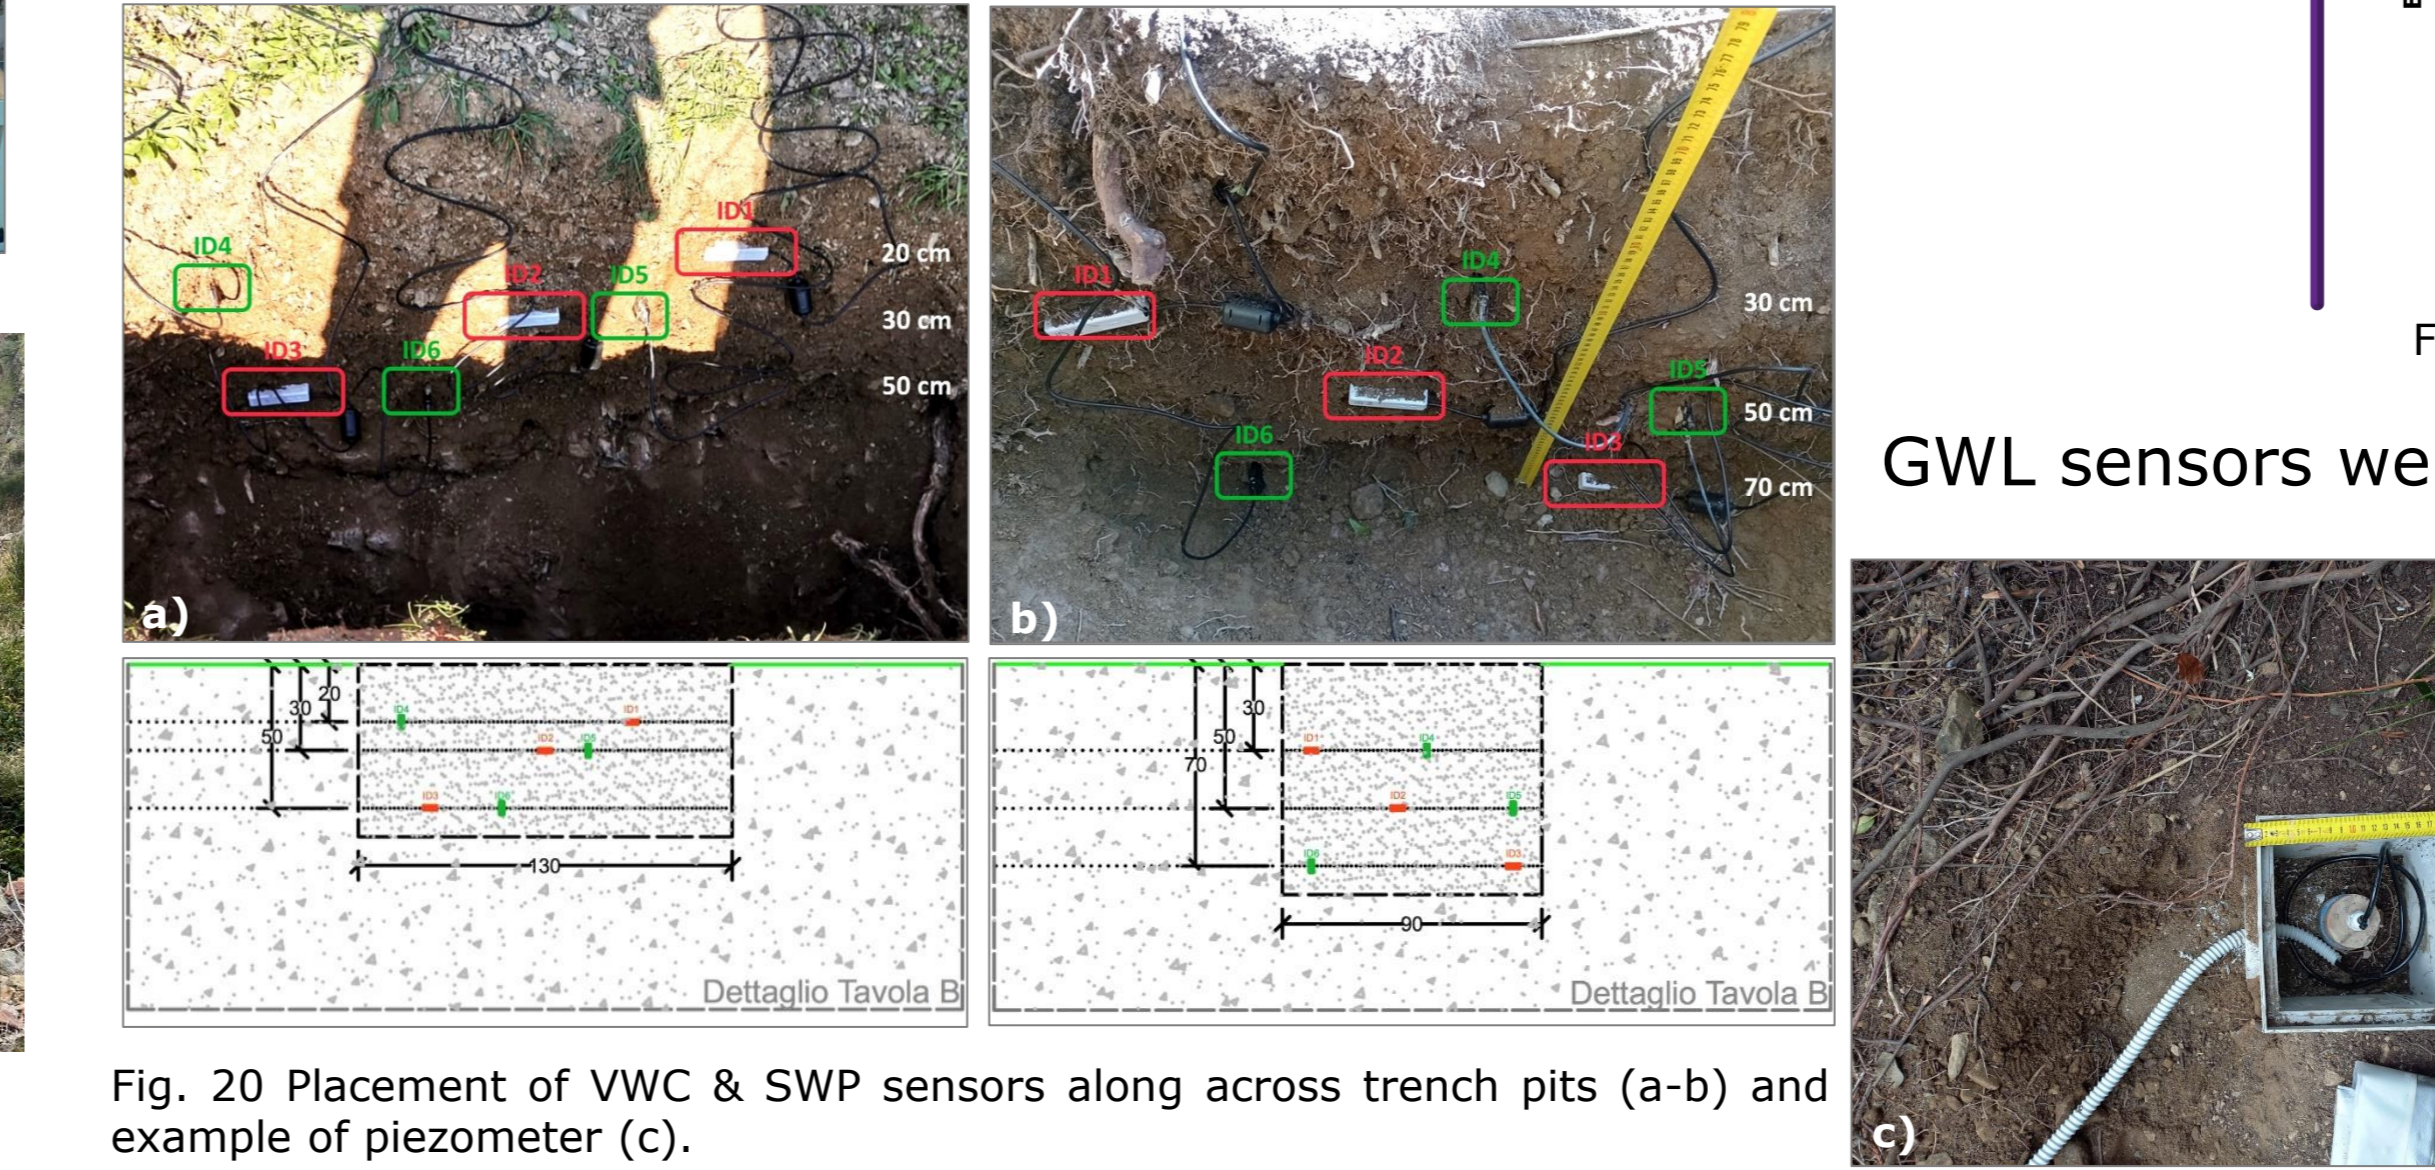
Fig. 20 Placement of VWC & SWP sensors along across trench pits (a-b) and example of piezometer (c).

Currently, two monitoring stations have been installed & are actively working. VWC & SWP sensors were positioned at three different depths in undisturbed soil layers within a trench pit and were connected to a datalogging system (Fig. 20).

GWL sensors were positioned into piezometer tubes installed into boreholes (Fig. 20).
